ENGINEERING NOTE

ANALYSIS OF SHAFT FAILURES

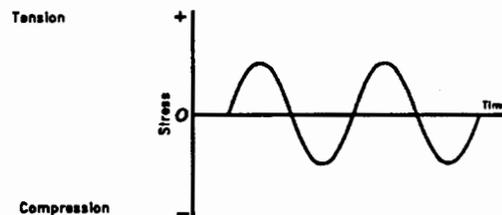
Figure I

These loads cause the material fibers to be in tension on the side of the shaft toward the load and in compression on the side opposite the applied load. As the shaft rotates 180° the stresses are reversed. After another 180° rotation, the stresses are again reversed; back to the original condition. So for every revolution, the surface of the shaft at any point will be stressed for a maximum tension to maximum compression and back again. See Figure I. For a motor shaft, it could easily be 1700 times per minute.

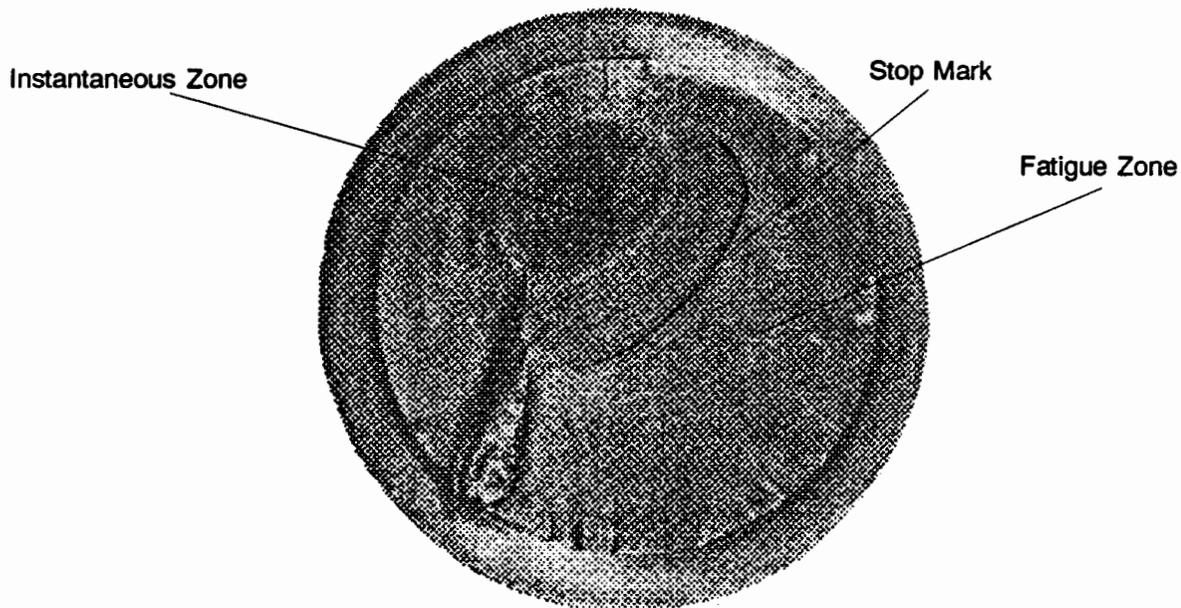
Figure II

The fracture face of a shaft that has failed from bending fatigue is composed of two distinct regions; the fatigue zone and the instantaneous zone. See Figure II.

The fatigue zone will be at the outer areas of the shaft. It is characterized by a smooth surface which is caused by the continual rubbing that takes place between the crack surfaces. The smoothed areas of the fracture is further identified in most failures by what are known as fatigue stop marks or "beaches".

The instantaneous zone will be toward the center of the shaft is characterized by a rough, grainy surface. This is the area that failed suddenly and did not get smoothed by the rubbing action that took place in the fatigue zone.

If it is determined that a shaft has failed from fatigue, corrective action must be taken or the replacement shaft will surely fail in the same manner. If a reducer shaft that was direct coupled failed, then the shaft it was coupled to was not properly aligned, or in the case of an unsupported agitator shaft, the shaft radial movement was excessive producing too much overhung load. Proper shaft alignment must be assured. If the shaft had a gear, sprocket, sheave, etc., then again the overhung load was too great. Gears, sheaves and sprockets must be of adequate diameter and located as close to the shoulder as possible. If the above recommendations cannot be achieved, then the reducer must be oversized to assure adequate shaft strength.
